REPORT NO. 3617  
UNION PACIFIC RAILROAD COMPANY  
IN RE ACCIDENT  
AT SOUTH MONTESANO, WASH., ON  
MARCH 15, 1955

REPORT NO. 3617

Accident at South Montesano, Wash., on March 15, 1955,  
caused by failure properly to control the speed  
of the following train moving within yard limits.

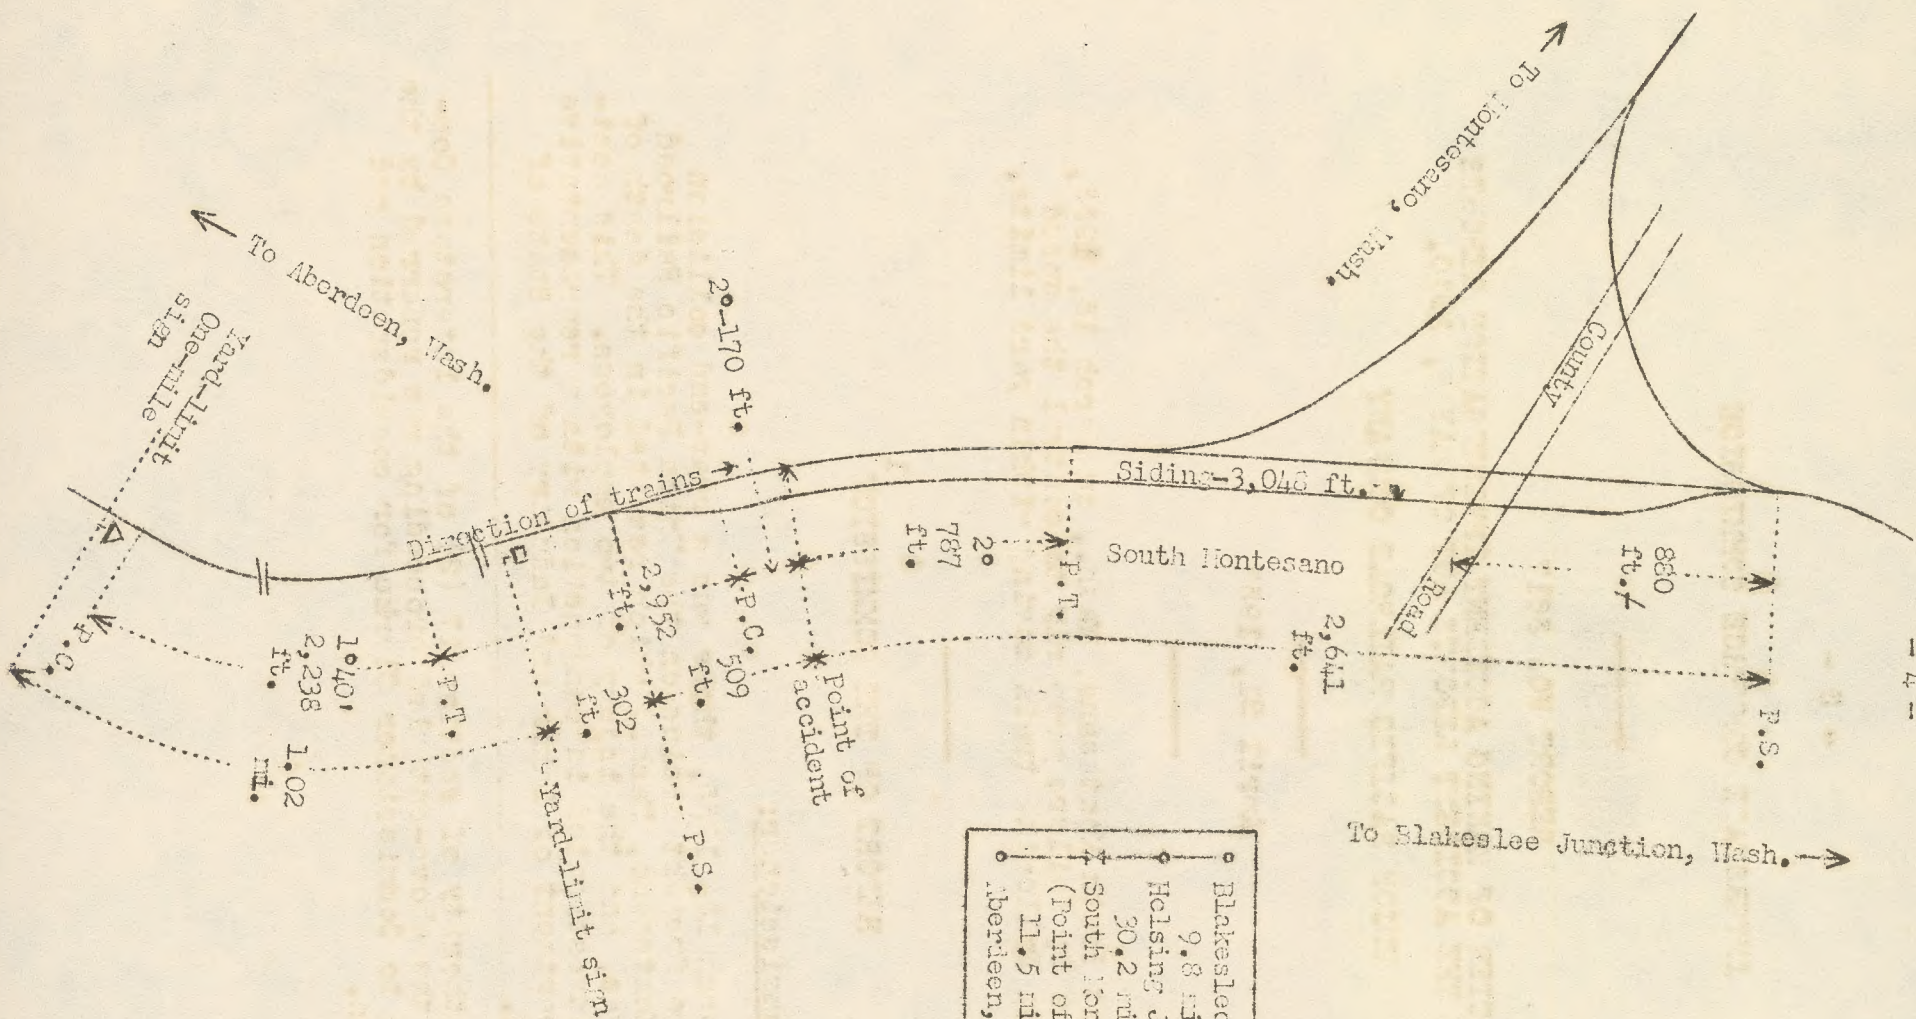
Report No. 3617  
 Union Pacific Railroad  
 South Montesano, Wash.  
 March 15, 1955

Blakeslee Junction, Wash.  
 9.8 mi.  
 Holsing Junction  
 30.2 mi.  
 South Montesano  
 (Point of accident)  
 11.5 mi.  
 Aberdeen, Wash.
